MISCELLANEOUS PAPER H-78-12

SOUTH JETTY STABILITY STUDY MASONBORO INLET, NORTH CAROLINA

Hydraulic Model Investigation

October 1978

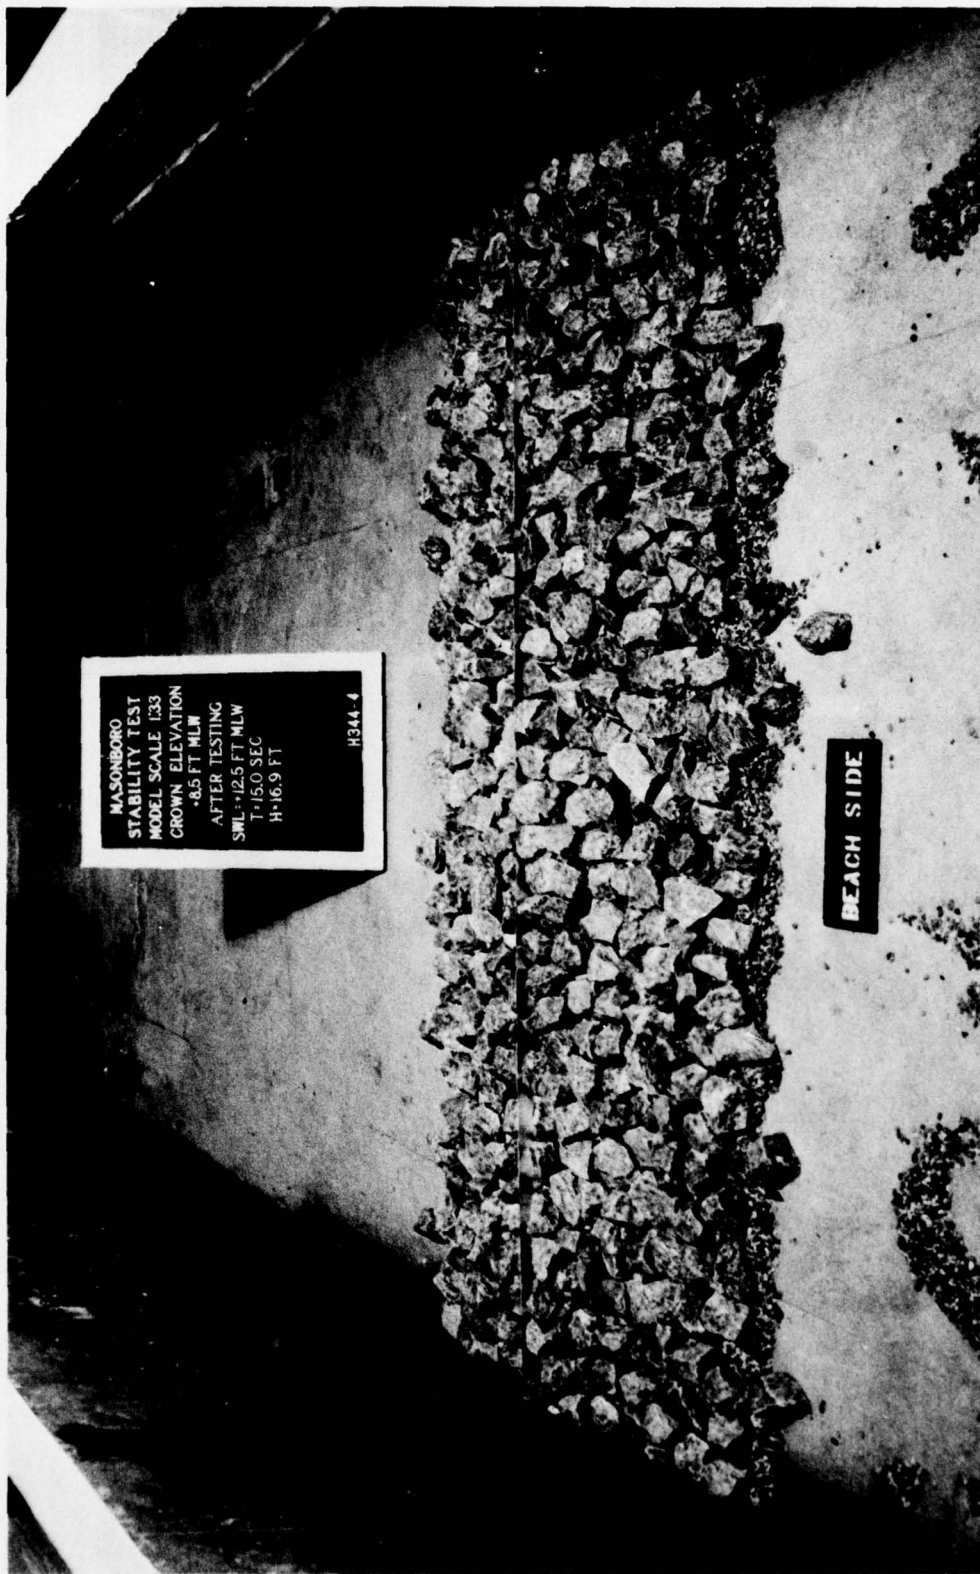
Photo 4. Beach-side view of Plan 1 after attack of 15-sec, 16.9-ft waves at an swl of +12.5 ft mlw for 4 prototype hr

10. Plan 1 (Plate 3) was constructed to a crown elevation of +8.5 ft mlw. Twelve-ton armor was used both sea side and beach side. Vertical sheet piling, which will be used in the prototype to an elevation of +6.5 ft mlw, was simulated in the model with 18-gage galvanized sheet steel. Plan 1 was initially subjected to 14-sec, 6.4-ft waves at an swl of +1.4 ft mlw for 1 prototype hour. No damage was observed for this wave condition. The swl was then raised to +5.0 ft mlw and the structure was subjected to 1 prototype hour of 15-sec, 9.5-ft waves. Again, no damage was observed. The structure was then subjected to 15-sec, 13.5-ft waves for 1 prototype hr at an swl of +8.5 ft mlw. This condition produced minor damage with 2 sea-side armor stones and 1 crown stone being displaced onto the beach side of the structure. Finally, the swl was raised to +12.5 ft mlw and the structure was subjected to 15-sec, 16.9-ft waves for 2 prototype hours, and the structure experienced significant damage. As illustrated in Photos 1 and 2, the crown elevation was lowered to the extent that the sheet pile wall was exposed in several places. Since damage to the structure had not stabilized, testing was extended for 2 more prototype hours. As shown in Photos 3 and 4, the structure continued to deteriorate. The seaward crown elevation was significantly lowered and the sheet pile wall and the sea-side armor were separated to the extent that a gap was opened between the two which significantly exposed the core stone. Since the structure had deteriorated past the point of acceptability, the tests were terminated.

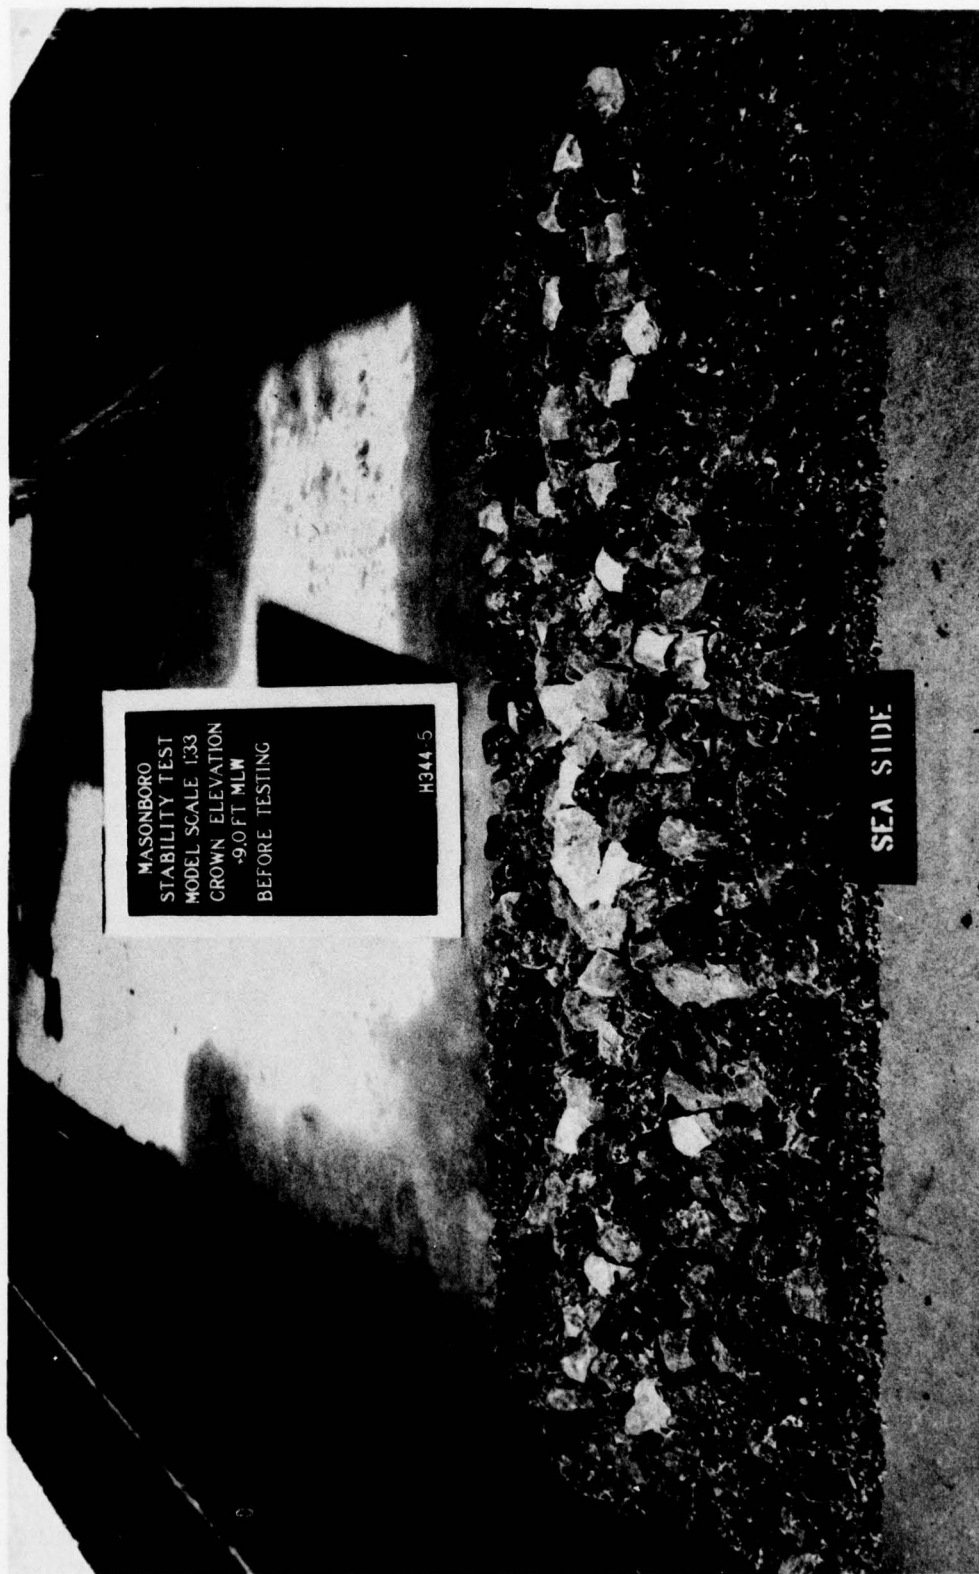
Photo 5. Sea-side view of Plan 2 before wave attack

12. Plan 2 (Plate 4 and Photos 5 and 6) was similar to Plan 1 except the crown elevation was raised to +9.0 ft mlw, the sheet piling was eliminated, and the armor weight was increased to 15 tons. The structure was initially subjected to 15-sec, 13.5-ft waves at an swl of +8.5 ft mlw for 2 prototype hours. Moderate damage was observed; however, the structure's stability response was judged to be marginally acceptable. The swl was then raised to +12.5 ft, and the structure was subjected to 15-sec, 16.9-ft waves for 2 prototype hours. As shown in Photos 7 and 8, this wave condition produced extensive damage. The average crown elevation was lowered 3 to 5 ft. Both the sea-side and beach-side slopes were flattened to approximately 1:3, and the core material was exposed in several places.

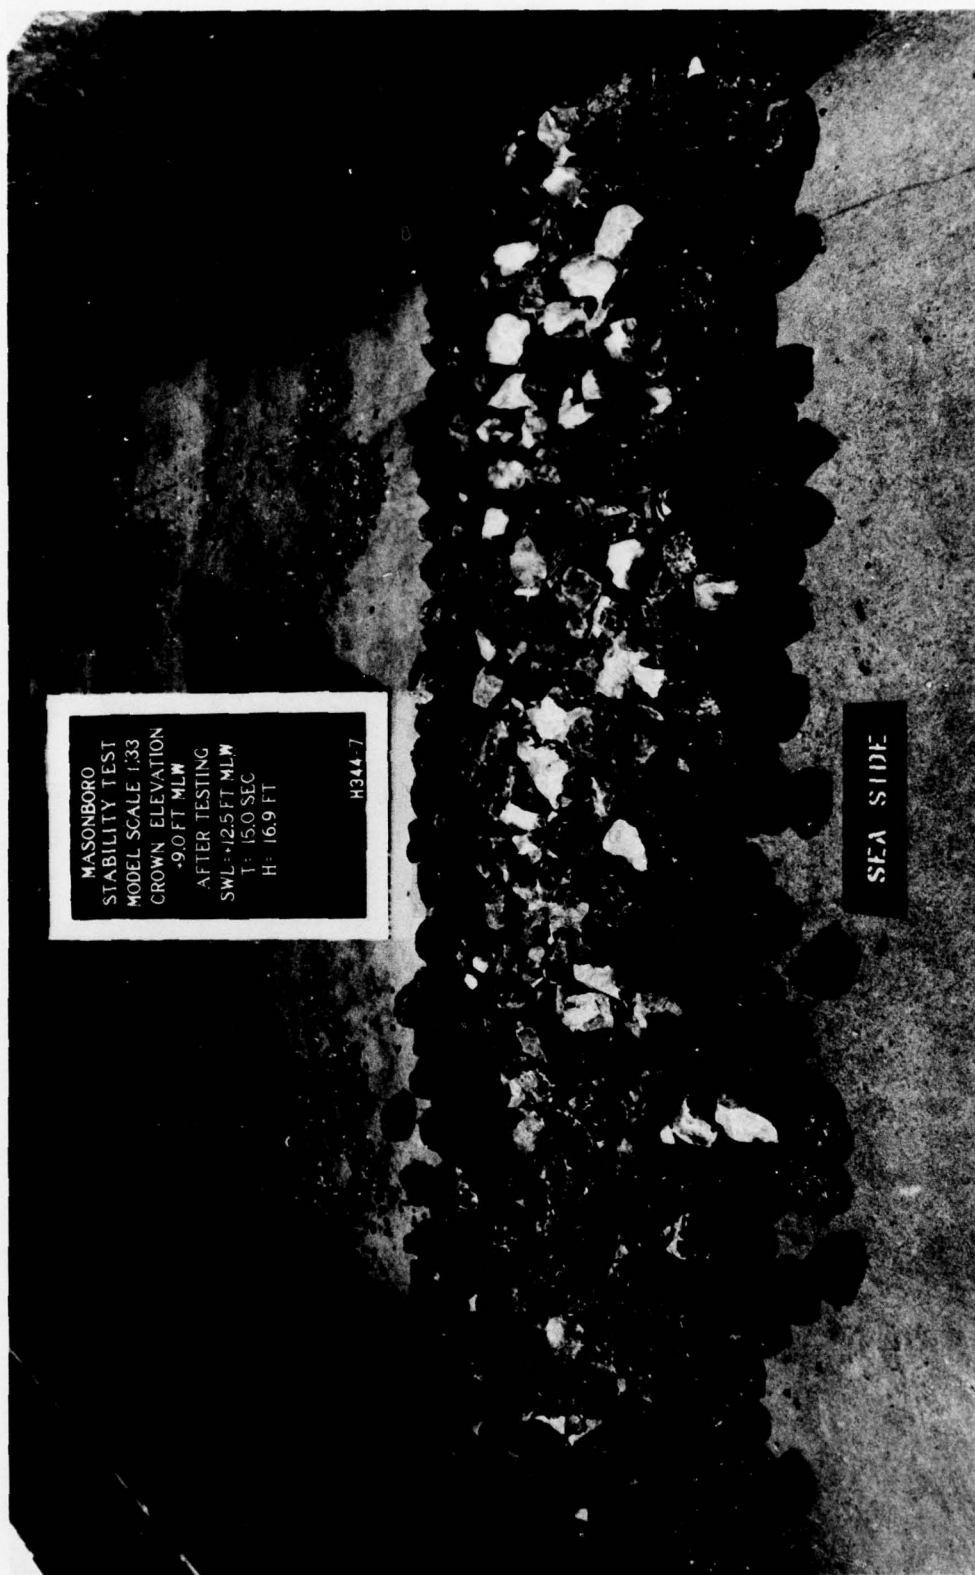
MASONBORO
STABILITY TEST
MODEL SCALE 1:33
CROWN ELEVATION
-9.0 FT MLW
AFTER TESTING
SWL = +12.5 FT MLW
T = 15.0 SEC
H = 16.9 FT

Photo 7. Sea-side view of Plan 2 after attack of 15-sec, 16.9-ft waves at an swl of +12.5 ft mlw for 2 prototype hr

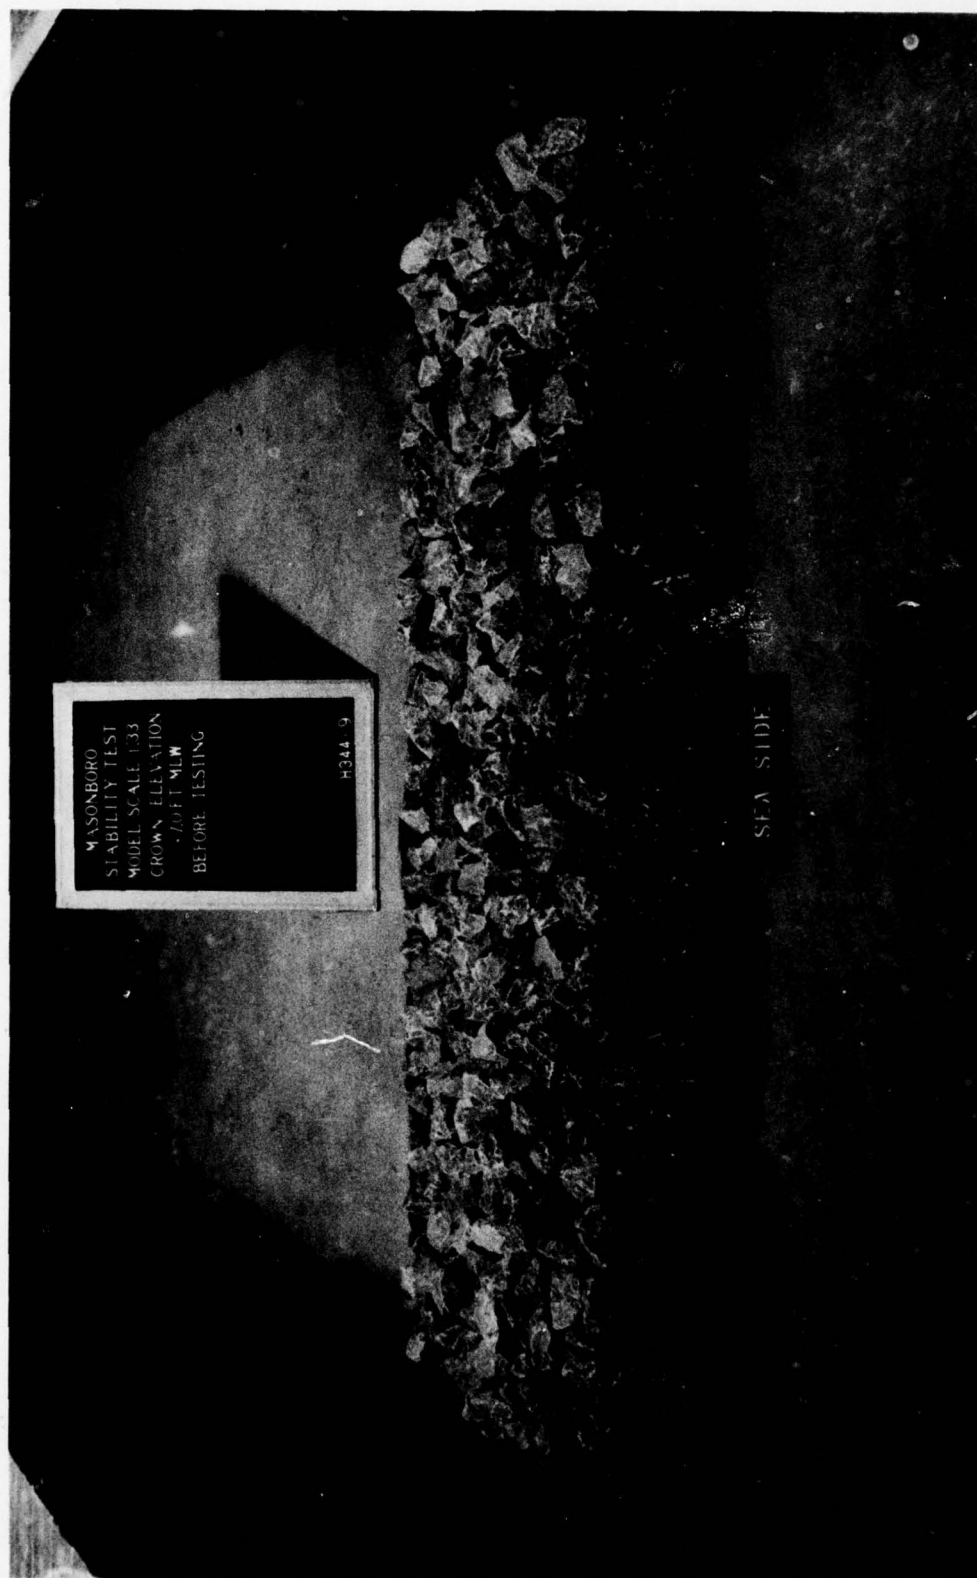
Photo 9. Sea-side view of Plan 3 before wave attack

13. Plan 3 (Plate 5 and Photos 9 and 10) was constructed to a crown elevation of +7.0 ft mlw and again excluded the sheet pile wall. Eighteen-ton armor was used both sea side and beach side. The bedding material (W_3) was covered with screen in an effort to simulate gabion mats which are to be used during prototype construction. Attack of 15-sec, 13.5-ft waves at an swl of +8.5 ft mlw for 2 prototype hours produced very minor damage to the first row of sea-side toe armor. The swl was then raised to +10.5 ft mlw and the structure was subjected to 15-sec, 15-ft waves for 2 prototype hours (it had been decided between the testings of Plans 2 and 3 to add an swl intermediate to the +8.5-ft and +12.5-ft swls). The +10.5 ft swl produced extensive damage to the sea-side toe. Also, the average crown elevation was lowered 1 to 2 ft and the core stone was exposed on several areas of the crown. Finally the swl was raised to +12.5 ft mlw and the structure was subjected to 15-sec, 16.9-ft waves for 2 prototype hours. As evidenced in Photos 11-13, this wave condition produced extensive damage. Seaward migration of both crown armor and core material resulted in an additional 2 to 3 ft lowering of the crown, and the core was randomly exposed such that it would take about 10 armor stones to cover the exposed areas represented

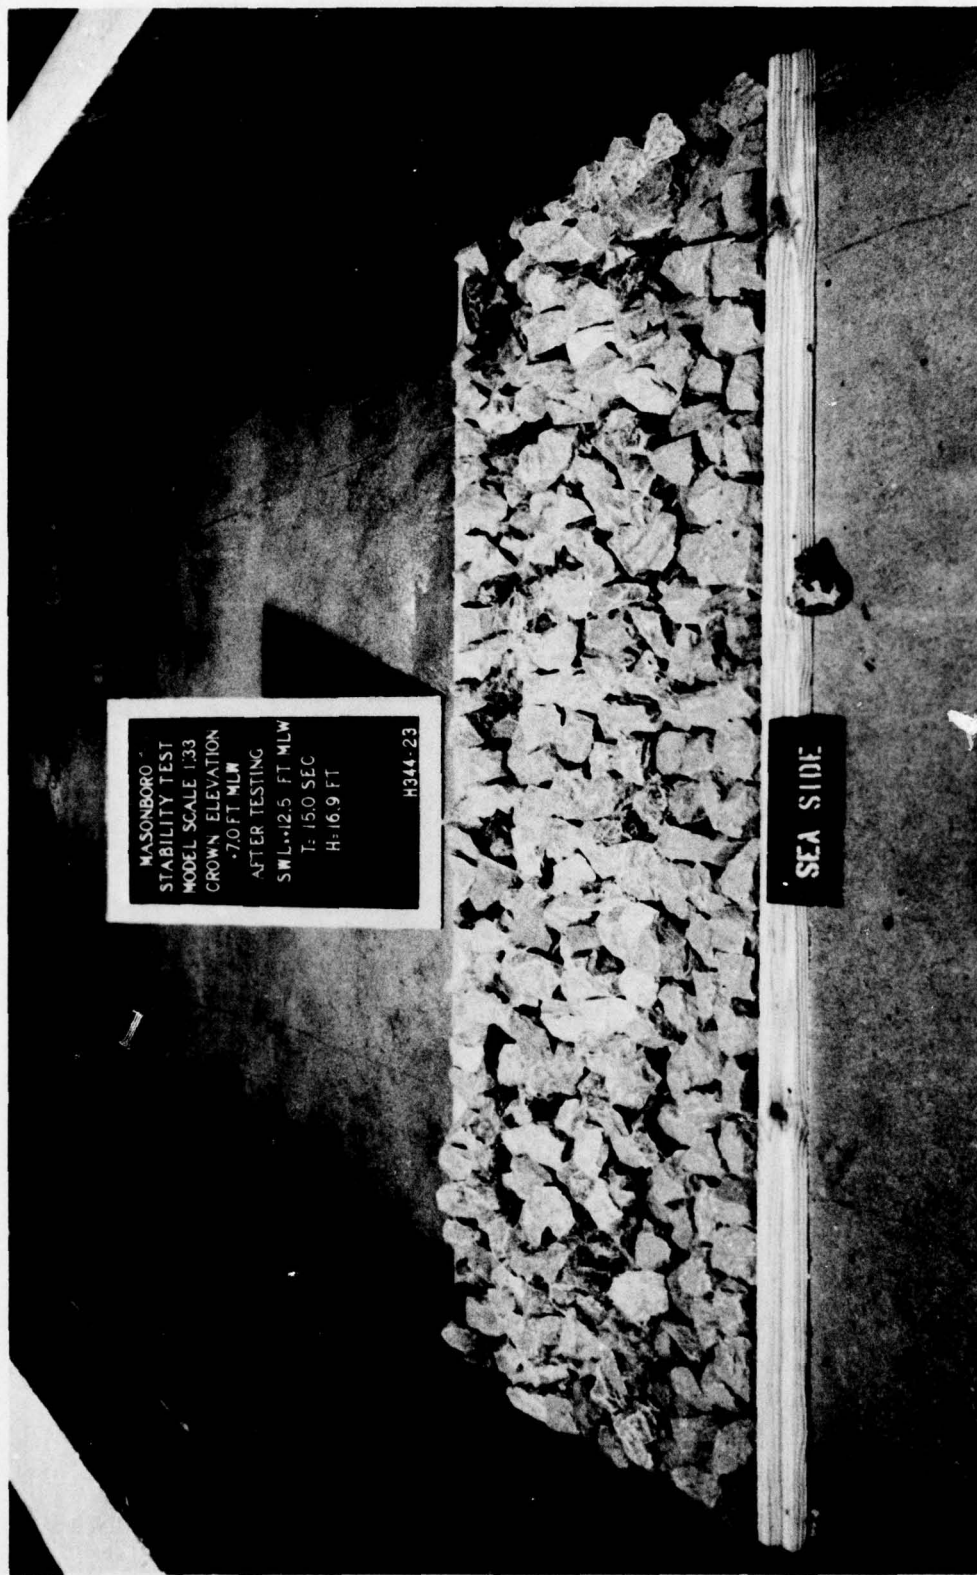
Photo 20. Sea-side view of Plan 3A after attack of 15-sec, 16.9-ft waves at an swl of +12.5 ft mlw for 2 prototype hr

15. Plan 3A (Plate 6) was the same as Plan 3 except small wooden strips were placed along the seaward and beachward toes of the structure to prevent horizontal sliding of the toe armor. The structure was initially subjected to 15-sec, 13.5-ft waves at an swl of +8.5 ft mlw for 2 prototype hours. As shown in Photos 14-16, this wave condition produced minor damage to the crown with 2 armor units being displaced onto the beach side of the structure. The swl was then raised to +10.5 ft mlw and the structure was subjected to 15-sec, 15-ft waves for 2 prototype hours. As can be seen in Photos 17-19, the structure's crown received moderate to extensive damage with the average elevation being lowered 1 to 2 ft. Seven armor units were displaced from the crown and the core stone was exposed in several areas sufficient to require 6 or 7 armor stones to cover the exposure. Finally the swl was raised to +12.5 ft mlw and the structure was subjected to 15-sec, 16.9-ft waves for 2 prototype hours. Referring to Photos 20-22, it can be seen that this condition produced extensive damage to the crown of the structure. The average crown elevation was lowered an additional 1 to 2 ft and exposure of the core stone became more pronounced, requiring up to a total of 10 or 11 armor stones, to cover the exposed areas. Repeat test verified Plan 3A's stability response.
